# Energy Audit On A Food Supply Site: An Industrial Case Study

**Abstract:** The study is based on the refrigeration equipment of a food supply chain company. The Group is a specialist in the transport and logistics of fresh and frozen products, and wanted to have a report drawn up on its energy requirements and to undertake action plans to reduce the electricity consumption of its equipment. The main objective of this study is to evaluate the energy performance of two machine rooms, in order to determine whether it would be possible to share certain equipment. The secondary objective is to optimise engine room 7 with the aim of improving its energy performance. The audit predicted an economic gain on equipment maintenance close to 30,000€/year, with a significant reduction in the environmental impact of this site. In addition, this energy audit has identified additional areas for improvement in machine room 7, which could lead to additional energy savings equivalent to €16,600 and a potential reduction of 15 tons of CO<sub>2</sub> emissions.

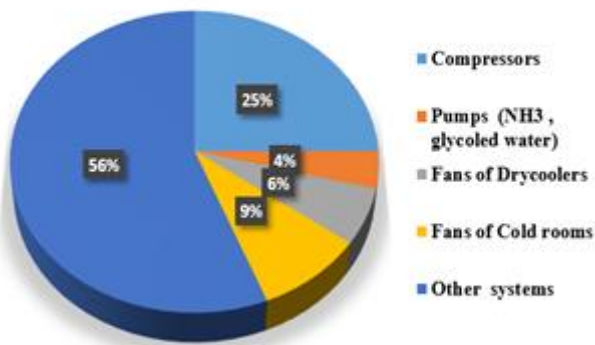
**Figure 2:** Breakdown of electricity consumption on the site

It is a company specialising in cold transport and logistics for all food and heat-sensitive fresh and frozen products. The company is located in the west of France. The photo (figure 1) shows the extent of the structure. The opening time of the company is 52 weeks/year, the number of employees varies from 200 to 299. The site has positive and negative cold rooms (CR) and administrative offices. The object of the study concerns the equipment of machine rooms 6 and 7 and the cold rooms they condition. The site operates on a just-in-time basis from Sunday from 7 pm to Saturday at 5 pm. Figure 2 shows the relative weight of the various energy consumptions on the site. It should be noted that the cold batch absorbs 44% of the total consumption, 25% of which is only for the screw compressors, which constitutes a significant share. The items included in "Other utilities" correspond to all other energy consumption (56%) not included in the audit.

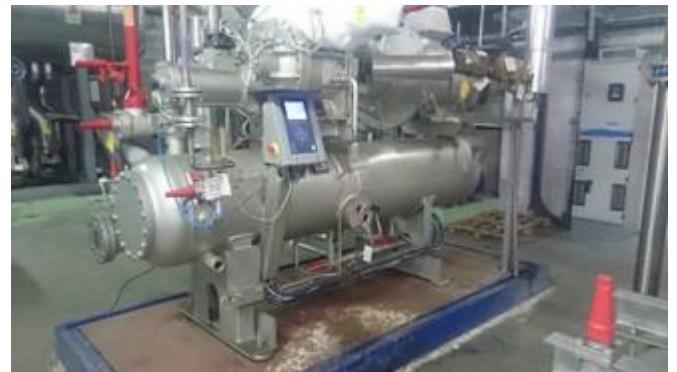
**Figure 3:** Front view of one of the three screw compressors

The production of negative cold (at -34°C evaporation) is ensured by a refrigeration plant operating in double stage NH<sub>3</sub> (in superfeed). This production (Figure 3) supplies 4 negative cold stores, all of which are controlled at a temperature set point of -18°C. The total volume to be refrigerated for the rooms is 68534 m<sup>3</sup>. The cooling is provided by three compressors. The characteristics of the three compressors are listed in Table 3.

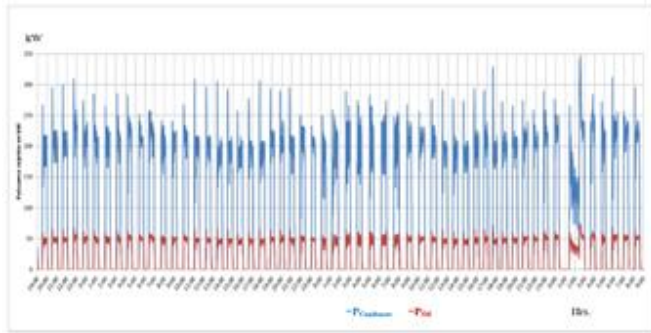
Figure 7: Evolution of heat fluxes released from MR6.

The plate condenser is equipped with PT 100 probes upstream and downstream (to measure the temperature difference between the inlet and outlet of the condenser), as well as an ultrasonic flow meter measuring the volume flow rate of glycoled water through the heat exchanger. This fluid flow contains 20% of Mono Ethylene Glycol (MEG). The recording of the aforementioned data by the acquisition system makes it possible to calculate and represent (Figure 7) the evolution of the heat output discharged by the condenser ( $P_{\text{condenser}}$ ). Oil cooling is very important on screw compressors in order to ensure the correct operation and durability of the installation. In fact, lubrication reduces friction and limits the temperature rise of the discharged gases. The cooling capacity of the oil can be approximated by the expression [5]:

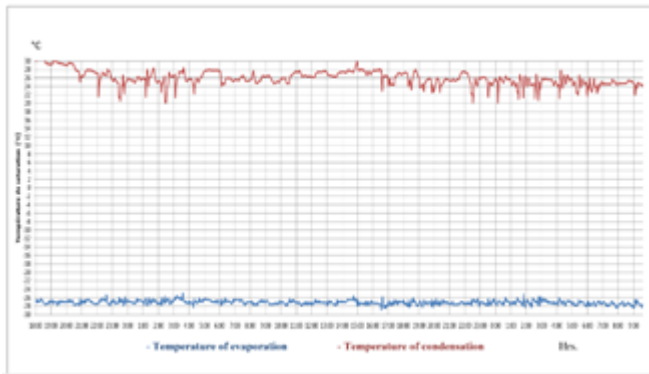
**Figure 11:** Evolution of the saturation temperatures of the compressor plant in MR7.

The low and high pressure saturating vapour temperatures of the compressor plant show a relatively stable operating regime and regulation (Figure 11). The range of variation is greater at the condenser, because the HP pressure is dependent to some extent on the fluctuating temperature of the outside air that cools the dry-cooler. The extreme values as well as the average temperatures of condenser and evaporator are recorded in Table 6.

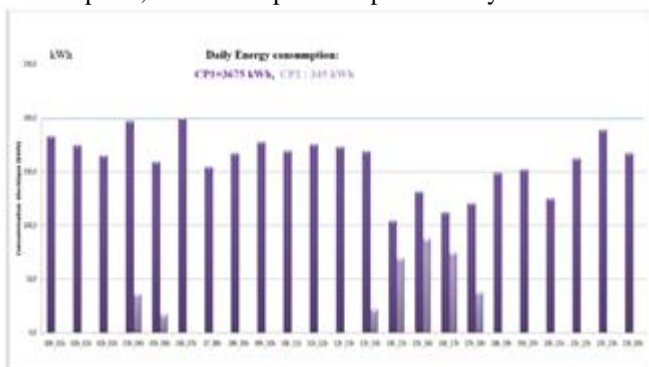
**Figure 13:** Trend in power consumption of MR7 compressors

The electrical consumption of the compressors (CP1 and CP2) in operation was determined on a typical day (Figure 13). The contribution of CP2 is only 8.5% of the total consumption, as this compressor operates very little.

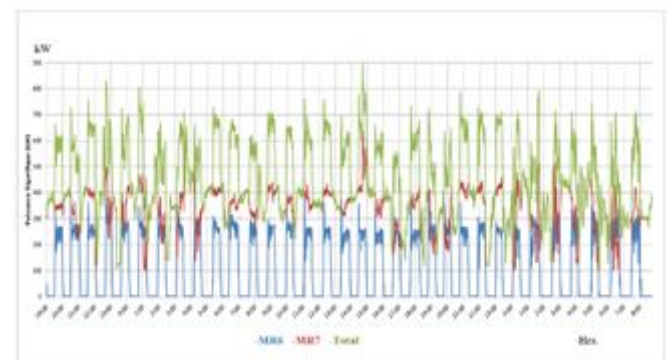
**Figure 19:** Total simultaneous cooling capacity of the MRs

Figure 19 shows the simultaneous cooling capacities of the two plants. This reflects the cooling capacity to be delivered by MR7 after the removal of MR6 and the connection of cold room No. 6. The graph represents the hourly cooling capacity of the cold rooms. It is a representation of the required future capacity of the engine room.

- When the refrigeration needs are  $\leq 400$  kWh/h, a compressor is sufficient to supply them.
- When the refrigeration needs are  $\geq 400$  kWh/h, one compressor is 100% engaged and the second one regulates according to the need.
- For example, from 3pm to 4pm, the cooling requirement was 550 kWh. One compressor provides 400 kWh, and the second one 150 kWh, which corresponds to a compressor operating at a frequency of 25 Hz, its minimum capacity (minimum operating threshold).
